**DEPARTMENT OF TRANSPORTATION****DIVISION OF ENGINEERING SERVICES**

Contract #: 04-0120F4Cty: SF/ALA Rte: 80 PM: 13.2/13.9File #: 69.28**WELDING INSPECTION REPORT****Resident Engineer:**Pursell, Gary**Address:** 333 Burma Road**City:** Oakland, CA 94607**Report No:** WIR-003333**Date Inspected:** 01-Jul-2008**Project Name:** SAS Superstructure**OSM Arrival Time:** 630**Prime Contractor:** American Bridge/Fluor Enterprises, a JV**OSM Departure Time:** 1530**Contractor:** Zhenhua Port Machinery Company, Ltd (ZPMC), Changxing Island **Location:** Shanghai, China

## WELDING INSPECTION REPORT

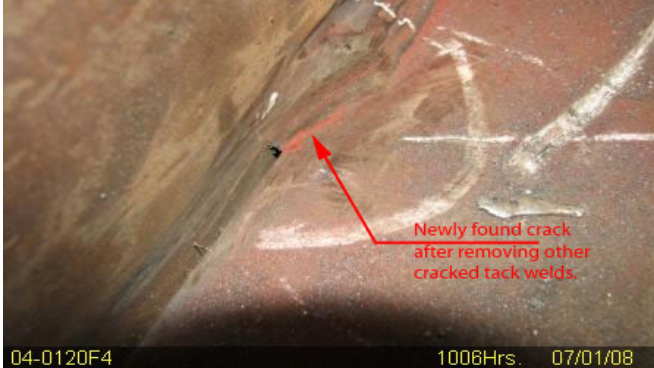
Bay 4: Newly found cracked tack welds on fillet weld connection of tower diaphragm plate to diaphragm flange SSD1-SA 335-1 after removing other tacks that have cracked.

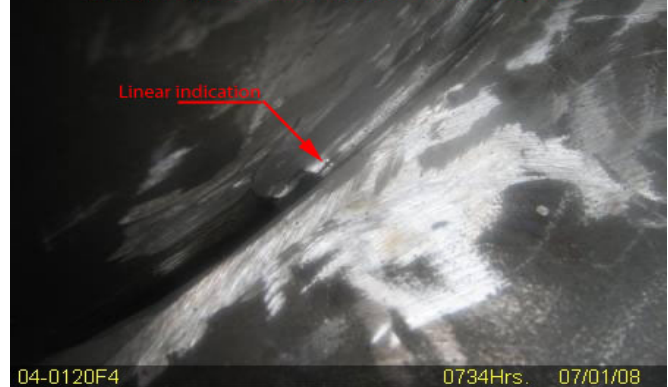
This QA observed two fillet weld connections between tower diaphragm plate to diaphragm flange that have cracked tack welds removed remain the same as of this day. Fillet weld connection SSD1-SA27 A/B-8 has one tack weld still with visible crack and other tack weld gap opening became ~12.0mm due to grinding on the edge of the plate. Per ZPMC/QC, there was linear indication at the plate base metal that they chased during their Magnetic Particle Test. The other fillet weld connection SSD1-SA335-7 has six tack welds, four of them completely removed but still with remnants in between and two tacks just ground up to the plate level. On two locations wherein ZPMC removed cracked tack welds, there were new cracked tack welds found nearby. This QA also observed NSD1-SA322 A/B weld connection same as mentioned above to have 10.0mm gap in between diaphragm plate to flange. See photo below.

Bay 4: Tack weld partially removed on fillet weld connection SSD1-SA27 A/B-8 but linear indication still exist at one end.

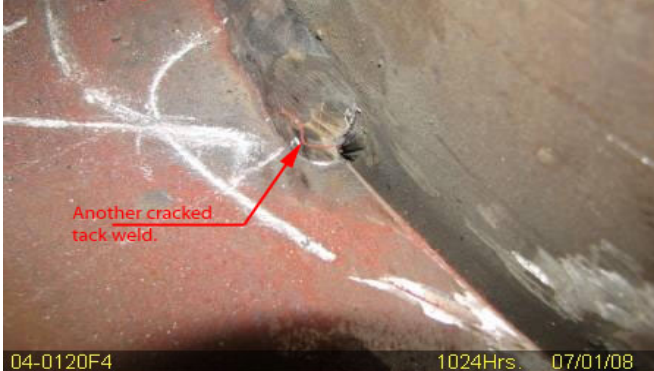
Bay 4: Another newly found cracked tack weld on fillet weld connection between tower diaphragm plate to diaphragm flange on SSD1-SA335-1 after removing cracked tack welds.

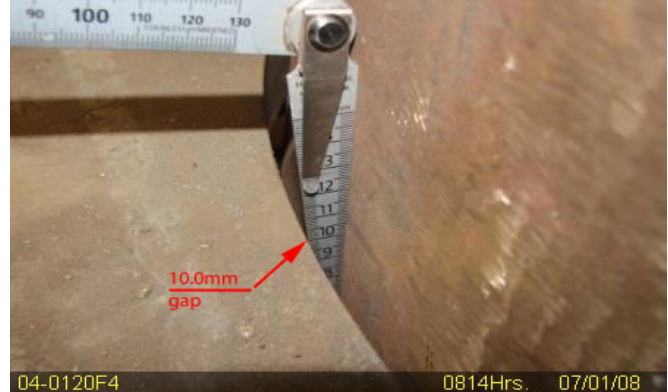
Bay 4: Fillet weld connection between tower diaphragm plate to diaphragm flange NSD1-SA322 A/B having 10mm gap.
